THE ATHENS (GREECE) EARTHQUAKE OF 7 SEPTEMBER 1999: THE EVENT, ITS EFFECTS AND THE RESPONSE

P. DIMITRIU, C. KARAKOSTAS AND V. LEKIDIS

Institute of Engineering Seismology and Earthquake Engineering (ITSAK)

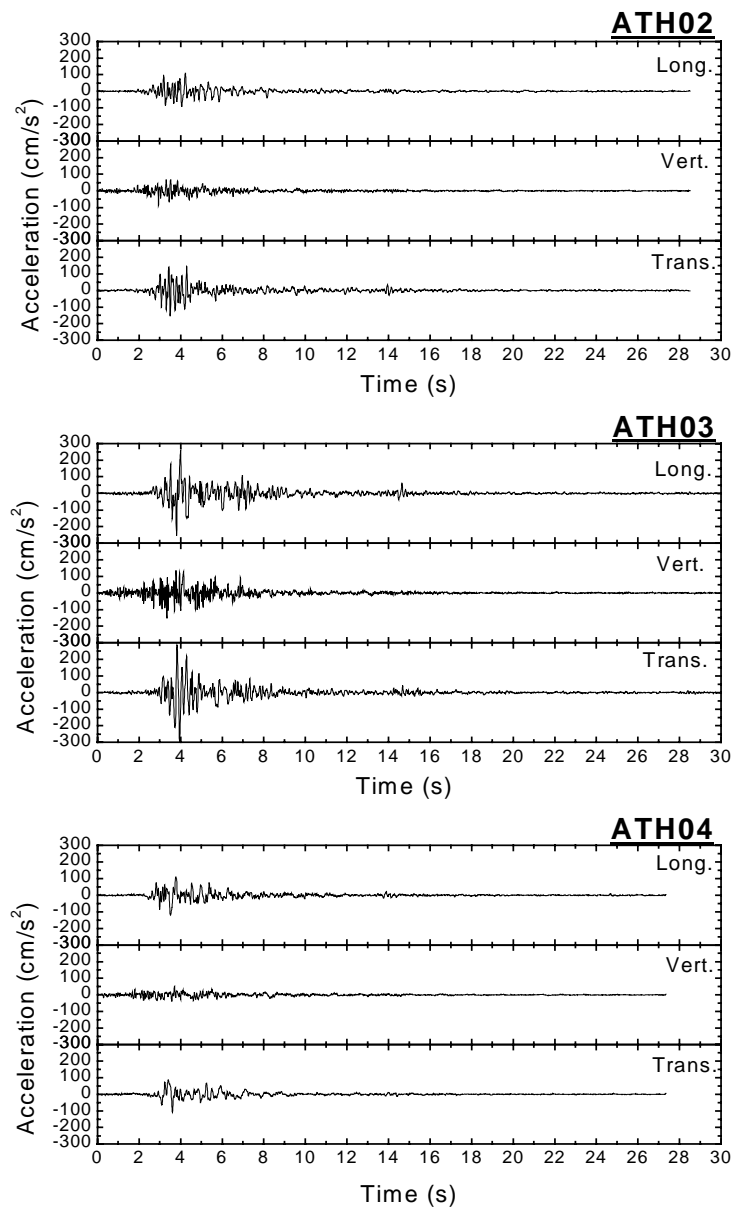
Figure 2. Corrected accelerograms of the 7 September 1999 (Mw 5.9) earthquake recorded by the permanent stations of ITSAK (see Fig. 1).

Upon a first comparison, the Athens earthquake appears to have been less severe than most of the events that recently hit major urban areas in Greece (Table 1). But one must keep in mind that the highest PGA unaffected by topography or other effects (0.35g) was recorded outside the meizoseismal area, at an epicentral distance of about 10 km. Within the meizoseismal area, closer to the fault, PGA may well have exceeded 0.5 g, especially considering near-fault and directivity effects, which apparently were significant. Moreover, there is macroseismic evidence that vertical accelerations may have locally exceeded 1g (e.g. the widespread unearthing of buried coffins at the cemetery of the municipality of Fili).

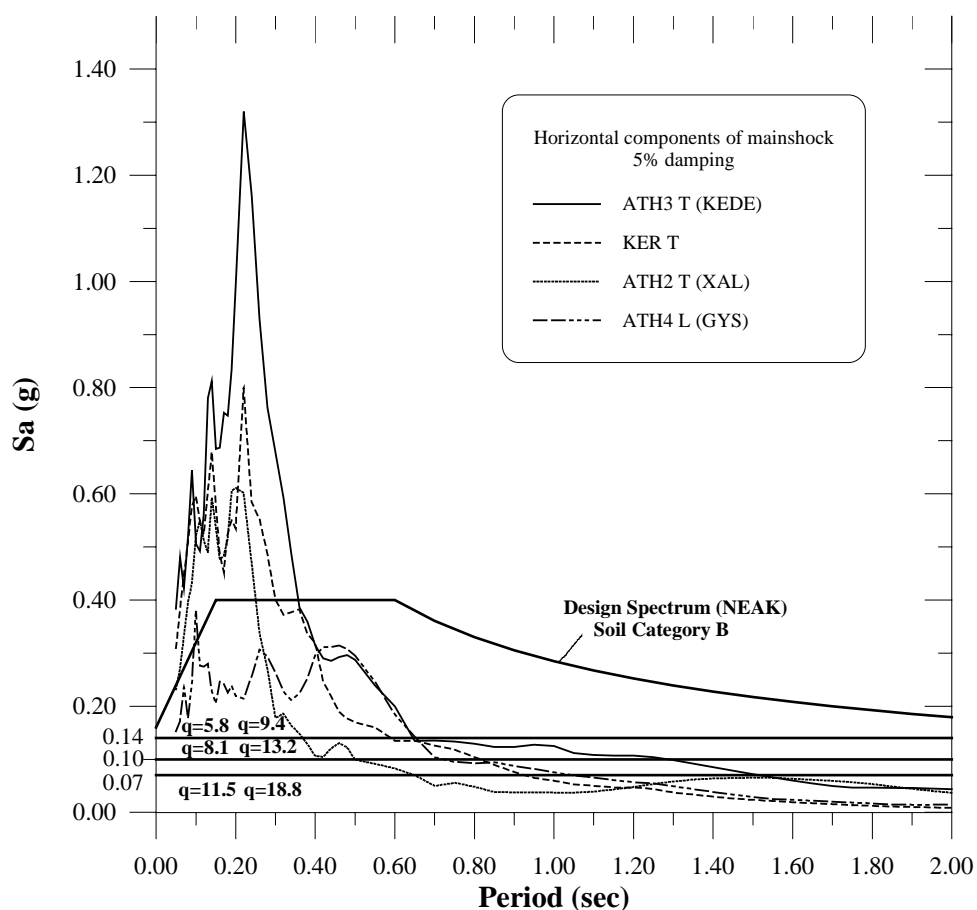
Figure 3. Acceleration response spectra (largest horizontal components) of the 7 September 1999 earthquake (M_w 5.9) and comparison with elastic design spectra of the New Greek Seismic Code - NEAK (enforced 1995) and the seismic coefficients of the 1959 and 1984 Seismic Codes.

To assess the ductility demands imposed by the earthquake on the buildings of Athens, the normalized peak values of its elastic response spectra are compared with the corresponding design base-shear coefficients, modified to account for ultimate-strength design requirements (Fig. 3). Comparison of the ductility demands, which depend on the ratio between the two above quantities, with what is estimated to be the available ductility reserves of the buildings provided by the code in force shows that the former exceed the latter in the critical period range. The earthquake, as revealed by the response spectra of the recorded motion (Fig. 3), had the strongest effect on low to mid-rise buildings (two to four stories). In this period range (0.2 – 0.4 s), the shaking intensity considerably surpassed the provisions of even the more conservative 1995 New Greek Seismic Code, based on ultimate-strength design. At periods corresponding to buildings with more stories ($T > 0.4$ s), spectral accelerations decrease rapidly.

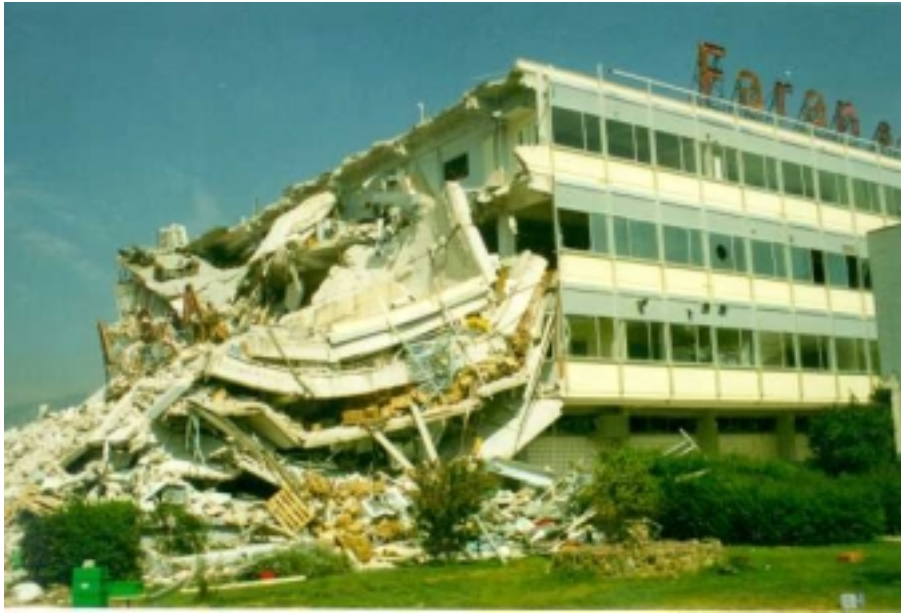
Since the earthquake struck during working hours, the greatest number of the deaths were caused due to the collapse of three industrial buildings (Ricomex SA, Fourlis SA and Faran SA) (Photo 1). These facilities were on, or in the vicinity of the banks of the Kifissos river (Chelidonou stream), which apparently greatly amplified shaking (site effects).

Photo 1. Partial collapse of an industrial complex (Faran SA).

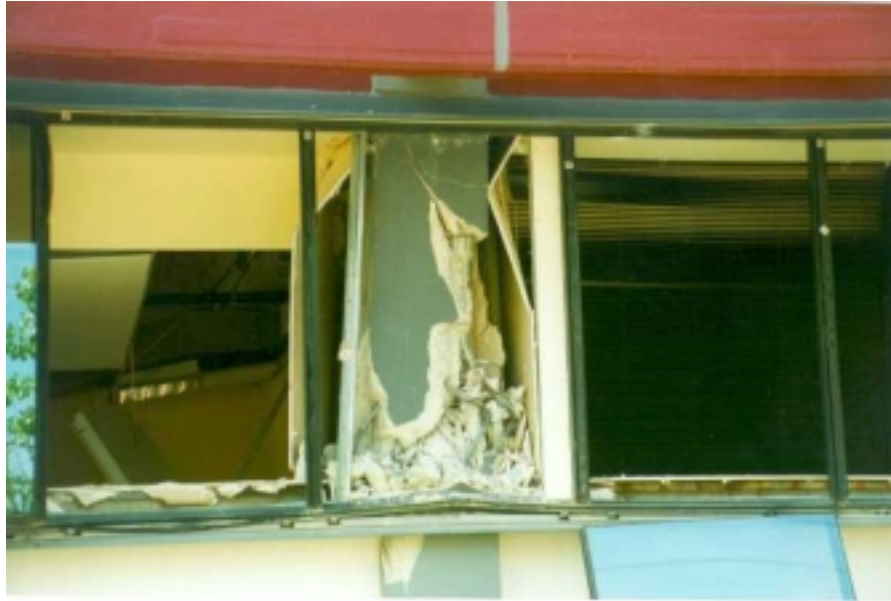
The observed building failures in the meizoseismal area are very similar to those observed in previous earthquakes in Greece (Ref. [3]). Typical examples include: (1) shear failures of short columns (Photo 2); (2) damage due to lack of adequate shear walls, particularly around staircases; (3) damage in columns and failures at joints or even total collapse of buildings with soft ground stories (pilotis) (Photo 3); (4) damage due to insufficient horizontal reinforcement (stirrups) in columns. Moreover, concrete in Ano Liosia was apparently of poor quality. Furthermore, a number of buildings suffered damage due to pounding with adjacent ones (Photo 3). The overall performance of newer buildings (built according to the 1984 and 1995 Seismic Codes) was rather satisfactory.

Photo 2. Column failure due to the short-column effect (Foullis SA industrial complex)

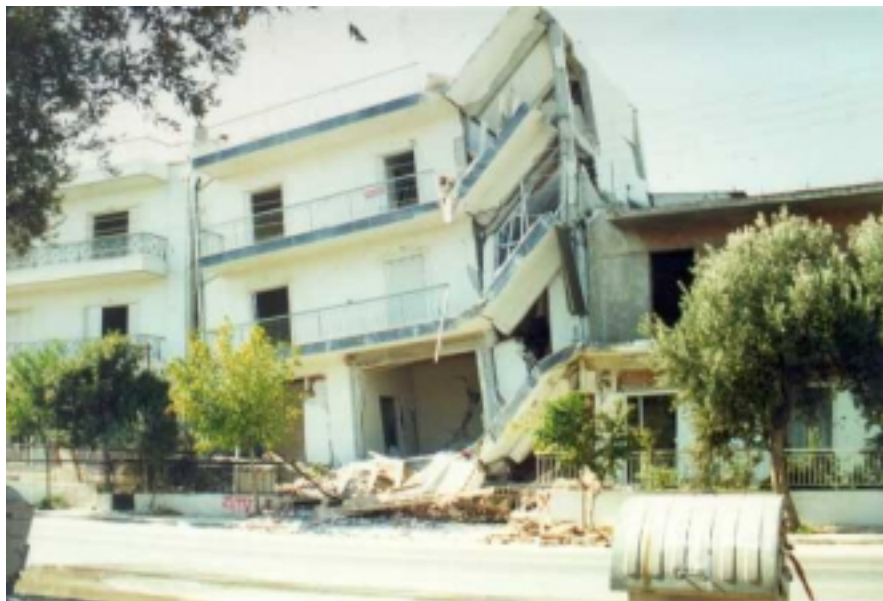
Photo 3. Soft ground story (pilotis) collapse of a mid-rise (4 story) building in the municipality of Menidi. Extensive damage on the right side possibly indicates pounding with the adjacent, lower-height building.
