**MISSION OF GERMAN TASKFORCE AFTER THE IZMIT (KOCAELI)  
EARTHQUAKE OF AUGUST 19, 1999:  
ANALYSIS OF AFTERSHOCK DATA AND STRUCTURAL DAMAGE**

*Lang, D. H., Schwarz, J., Raschke, M.*

*Bauhaus-University Weimar, Institute of Structural Engineering, EDAC - Earthquake Damage Analysis Center*

**- Extended abstract -**

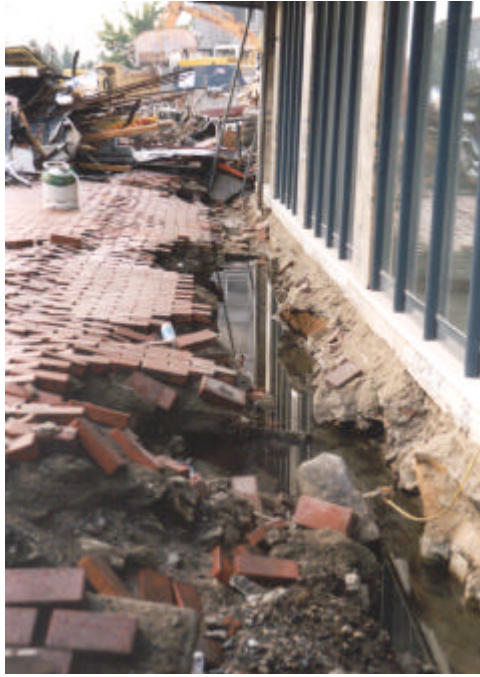
a)

*Figure 3. Site and subsoil effects:*

*a) settled and b) tipped buildings located on liquefiable silts and sands within Adapazari city,*

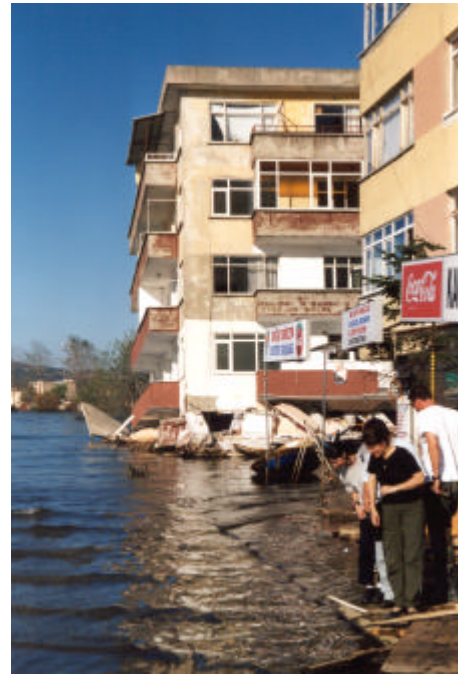
c)

*c) inundation of the coastal district of Gölcük provoked by tectonic displacement along the fault and liquefaction-induced subsidence*

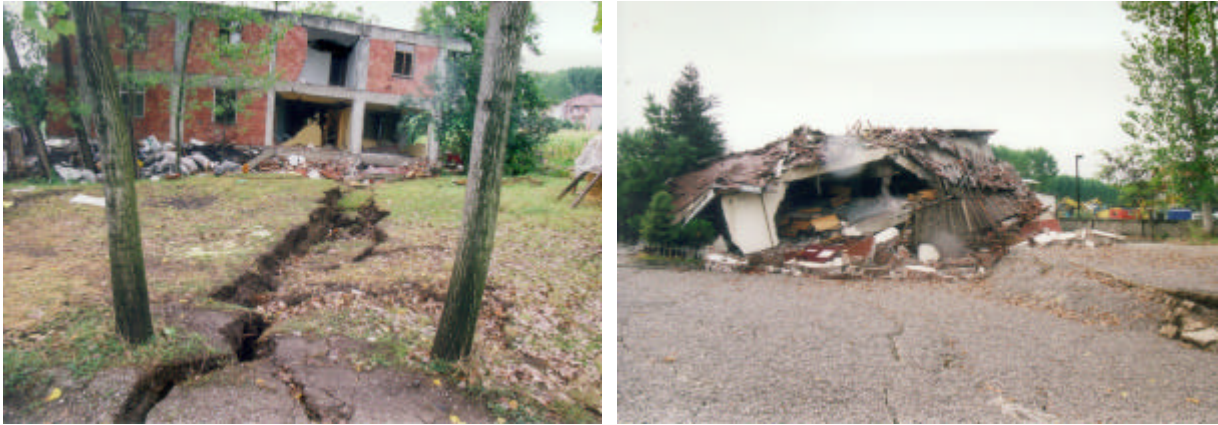
Furthermore, the disregard of fault effects and the missing consideration of endangered fault zones in regional land use planning resulted in many building collapses. Numerous buildings being located astride or in small distances to the surface rupture were totally destroyed due to large displacements in the foundation slab.

*Figure 4. Collapsed buildings in Yuvacik (east of Gölcük) being located astride the surface rupture*

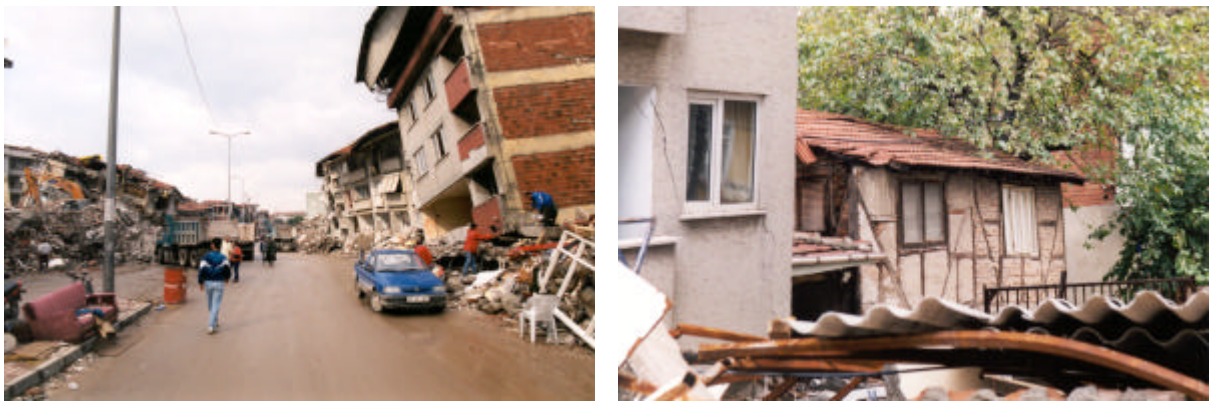
Another factor for the huge extent of building damage surely insists in the vulnerability of reinforced-concrete frame structures. Reports of damage were mainly concentrated on this building type, which is very popular for this region of Turkey. Traditional building types like timber frameworks with brick or adobe infills or simple masonry structures of one or two storeys often showed a better behavior under earthquake excitation and survived the main event without suffering any damage.

*Figure 5. A scene within Adapazari city: a) damage of "engineered" RC-frame structures, b) traditional building type (timber framework) in the vicinity*

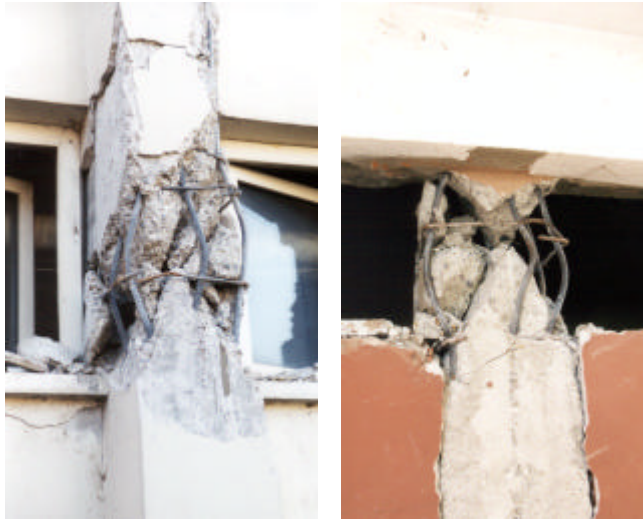
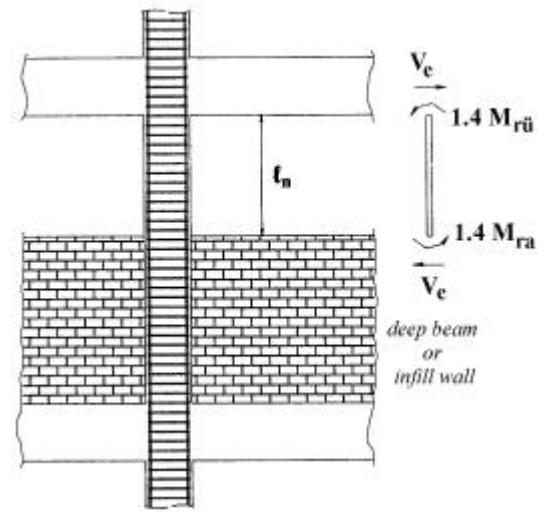
## Occurrence of "short-column" effects

The realization in practice

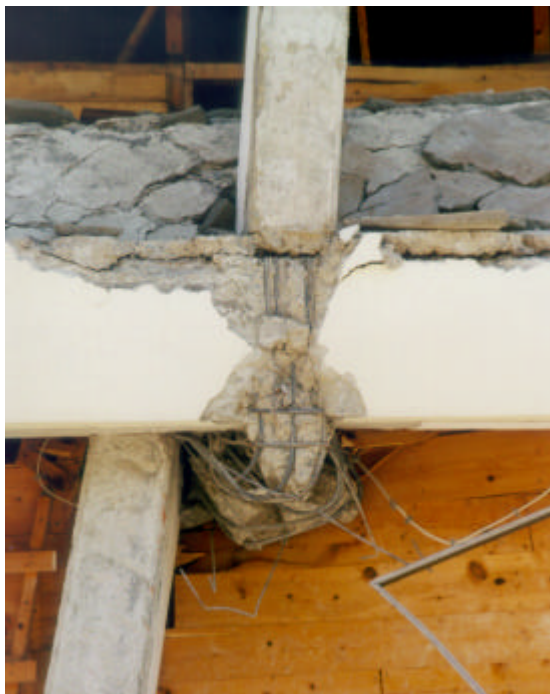
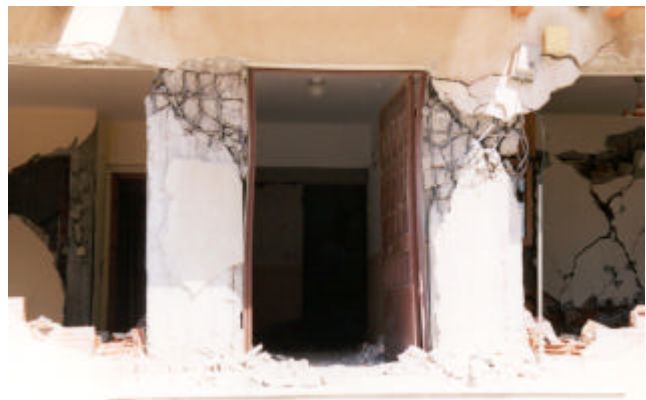
## Occurrence of "weak-column-strong-beam" effects

The realization in practice

„In structural systems comprised of frames (...), sum of ultimate moment resistances of columns (...) shall be at least 20% more than the sum of ultimate moment resistances of beams framing into the same joint (...).“

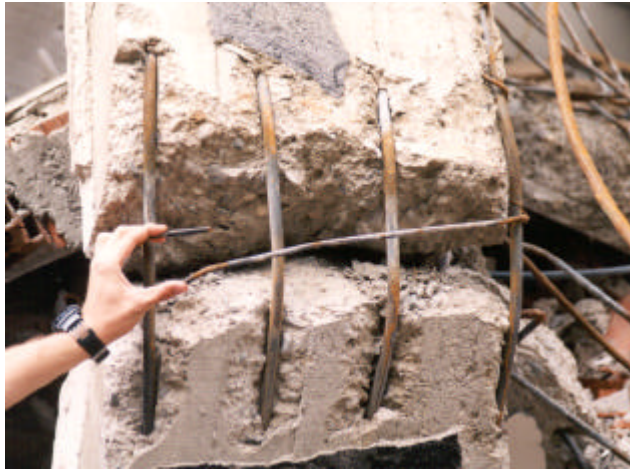
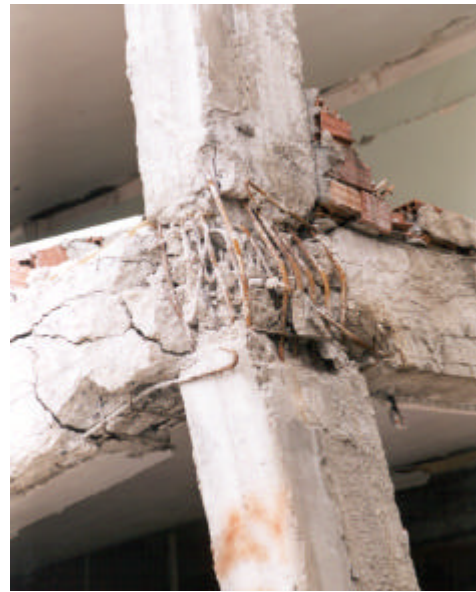
## *Application of seismic hoops and crosssties*

### *The realization in practice*
