# Topographic effects influencing large scale slope failure during the 21<sup>st</sup> of September Chichi earthquake, Taiwan, 1999.

The Central Cross Island Highway is a strategically important routeway through the Central Mountains of Taiwan. Strong shaking generated by the Chi Chi earthquake of 21st of September 1999 resulted in extensive slope failure that destroyed a section of the road to the west of the Techí Dam.

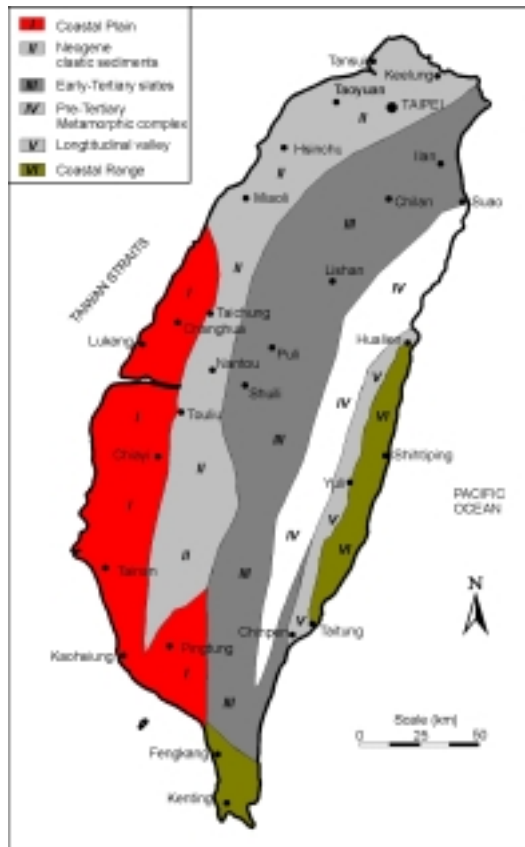
Figure 1. The general geology of Taiwan

The oldest units which are found in Taiwan are the marbles and gneisses of the pre-Tertiary metamorphic complex (figure 1) Only occasional rock slope failures were triggered in these rocks by the earthquake. Overlying these rocks are the early Tertiary slates which in turn are overlain by a group of Neogene clastic sedimentary rocks which are dominantly sandstones, siltstones and shales. These Neogene rocks have been deformed, although sedimentary structures can still be observed, as can occasional fossil fauna. The youngest rocks are generally found on the western coastal plain. These are Quaternary clastic sediments which showed liquefaction during the Chi Chi earthquake. The geology of the site under investigation is dominated by Neogene clastic

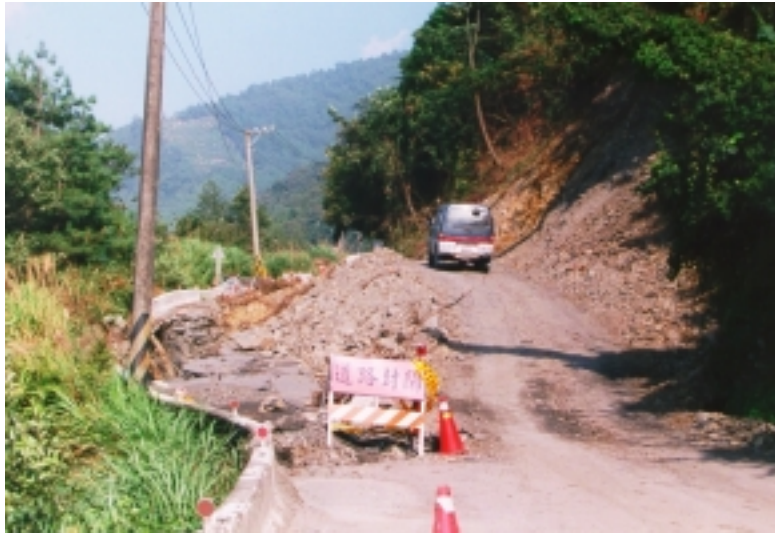
Figure 3. Damage to highway 8 by a seismically-triggered landslide near Lishan

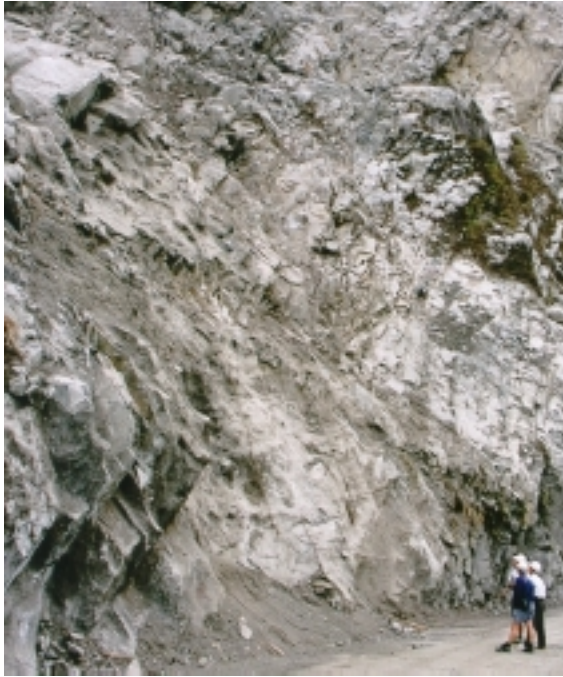
Figure 5. The rock mass observed at the Techi landslides

The local geology around the site was varied but not overly complex. The dam site itself is dominated by folded and faulted sandstones, siltstones and shales. There is a strong easterly dip to the bedding of about  $72^\circ$ . The bedding forms the dominant discontinuity, therefore the orientation of major fracture planes is not conducive to large scale slope failure. The rock mass is shown in figure 5.

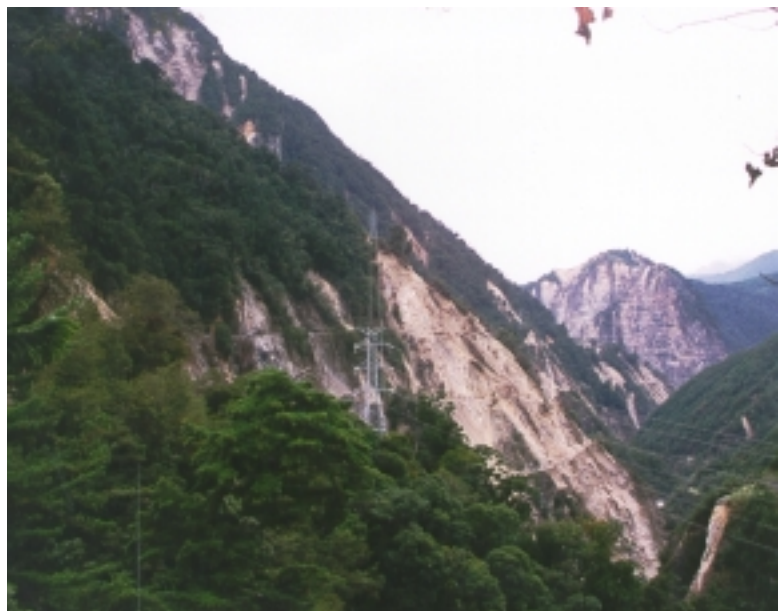
Figure 6. Overview of the landslides near the Techi Dam

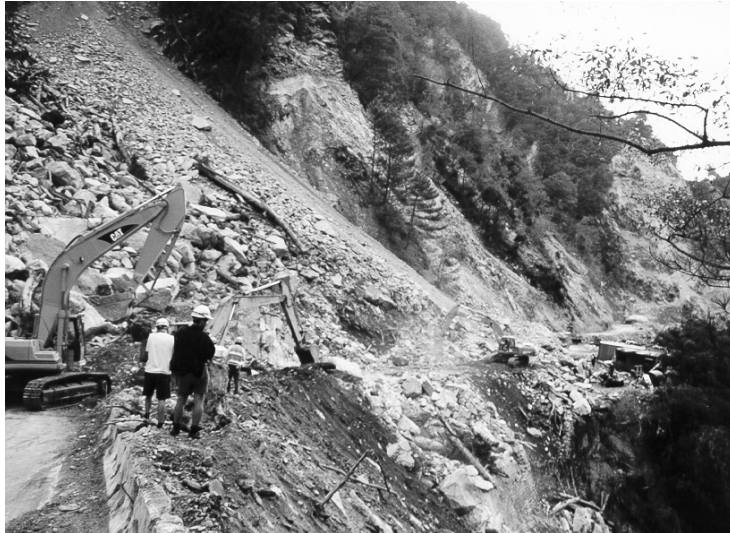
Figure 7. Clearance of rock slide debris from I8 near Techi

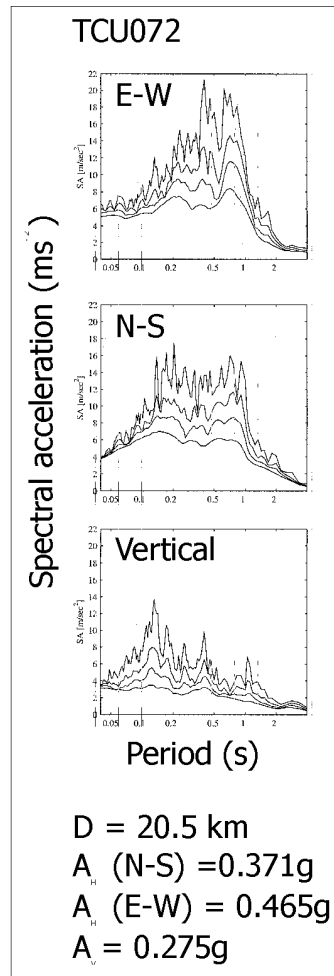
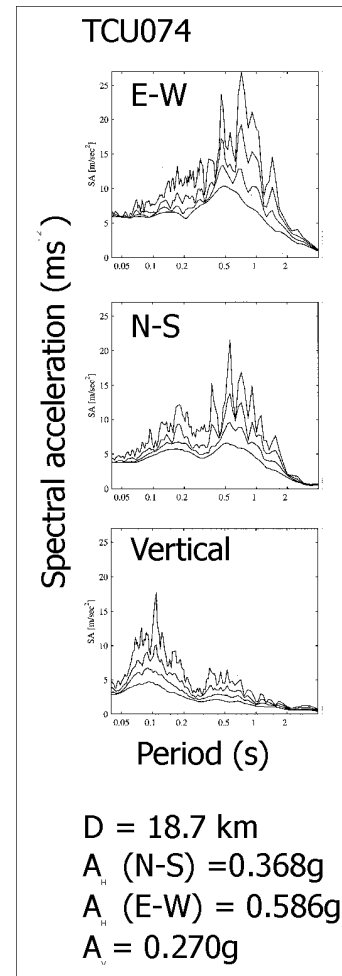
Figure 9. Response spectra calculated from accelerometer data collected from stations TCU072 and TCU074

The data from the two nearfield stations (TCU72 and TCU74) show spectra which are dominated by frequency modes at about 0.5s (2Hz) and 0.75 s (1.3 Hz) in the East-West direction. Both stations show long tails of high frequency data in the range of 0.2 – 0.05 s (5-20 Hz). The spectral accelerations of these motions is approximately  $5\text{ms}^{-2}$  (approximately 0.5 g). The ground motion data in the North-South orientation show similar characteristics, although the spectral

accelerations of these motions is somewhat higher in the East-West direction: 20-26  $\text{ms}^{-2}$  (2-2.6g) in the East-West direction as opposed to 18-20  $\text{ms}^{-2}$  (1.8-2.0g) in the North-South mode at 2% damping. Additionally, in the case of both nearfield stations, high vertical ground motions can be observed, the peak spectral acceleration values fall in the range of 14-18  $\text{ms}^{-2}$  (1.4 – 1.8 g) with the peak values being mobilised at the high end of the spectrum. These values decrease of course with increasing damping.

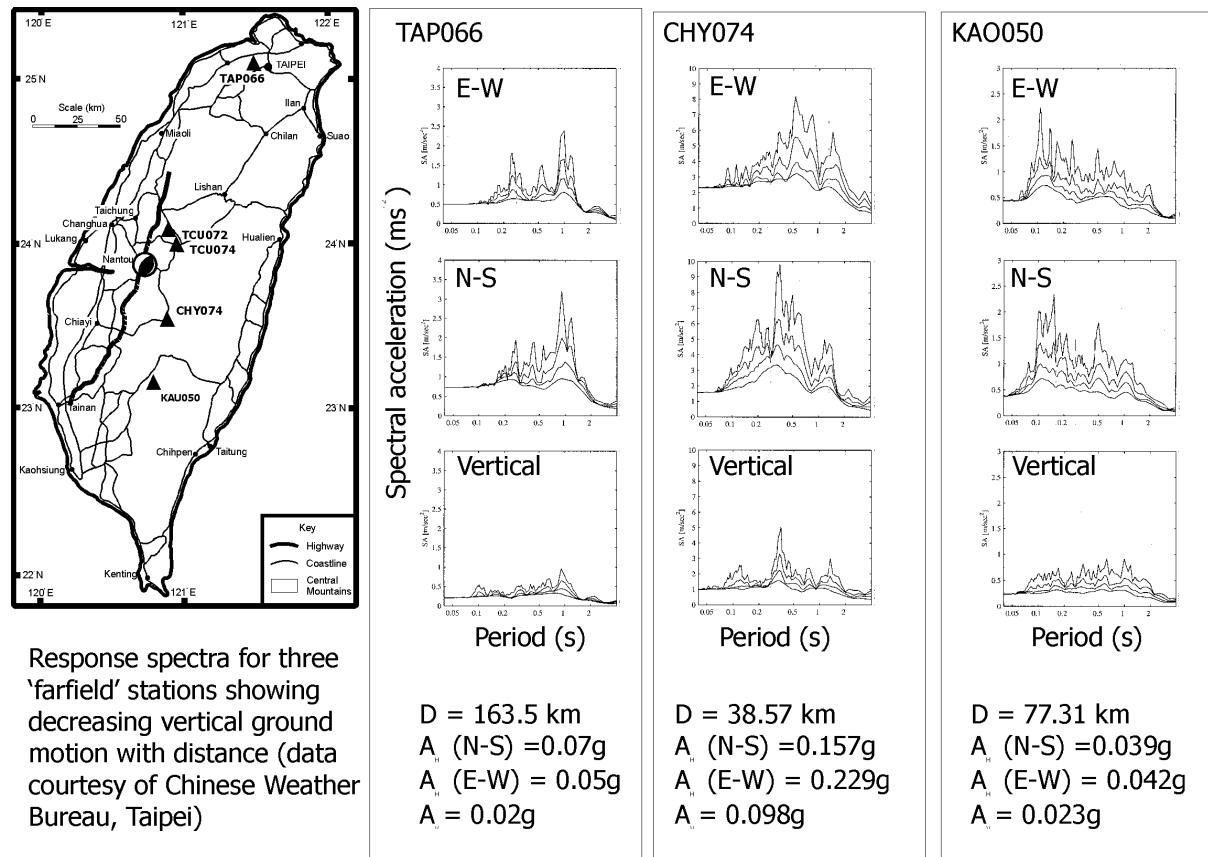
Figure 10. Response spectra calculated from strong motion data collected at stations TAP066, CHY074 and KAU050

The farfield stations show somewhat differing responses. Notably, the high frequency content of the ground motions recorded at KAU050 which although showing considerably lower values of spectral acceleration (2-2.5  $\text{ms}^{-2}$  horizontal and 0.5-1  $\text{ms}^{-2}$  vertical ground motions) shows a ground motion profile which is dominated by higher frequencies. Similarly, for station CHY074 there is a component of high frequency shaking observed in the horizontal and vertical response spectra. The station with the largest distance between the earthquake epicentre and the recording instrument (TAP066) shows a shift towards the maximum response being mobilised at higher natural periods (i.e. lower frequencies.)

It has been noted that the resonant frequency of hard rock masses tends to lie at the upper end of the frequency spectrum (Seed and Idriss, 1982). Normally, strong rock masses will resonate at a range of values between 8 and 20 Hz. Therefore, it is tempting to assume that failures near the Techi Dam site were the result of the resonance of the rock mass giving rise to unusually high ground accelerations. Indeed the range of frequency values observed in stations CHY074 and KAU050 do tend to support this interpretation.
