**Compound Growth or Compound Seismic Risk of Destruction?
Some vulnerability lessons from the Izmit, Turkey,
Earthquake of 17 August 1999**

Dr Ian L Nunez
AIR, 3 St Helen's Place, London EC3A 6AB

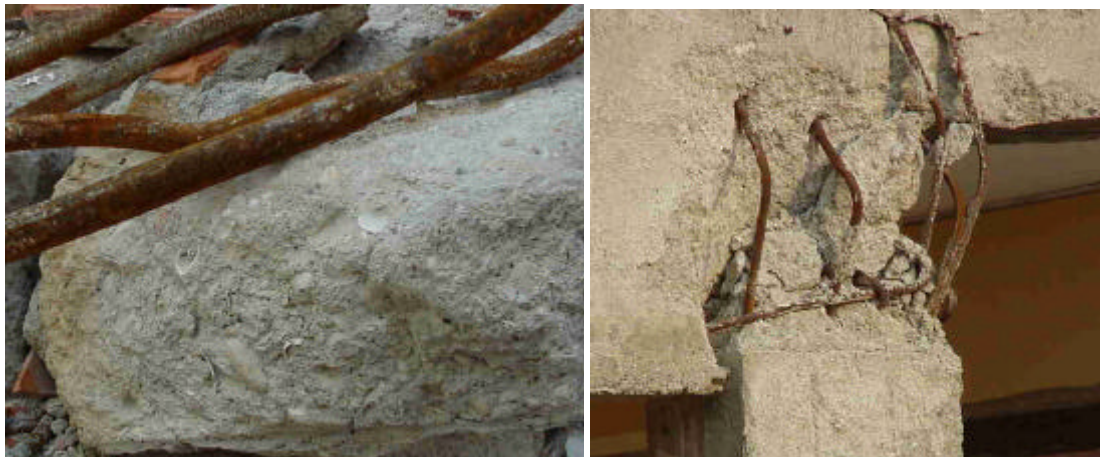
Although the ingredients of concrete are simple, they still have to be proper materials and mixed in the correct quantities and manner. Sea water will not do and neither will sea shells or beach sand as the aggregate. The salt in these materials would corrode the reinforcing bars, rendering them useless, and impair the "concrete". Surprisingly, these materials were found as constituents in many of the "RC" buildings around the Sea of Marmara, struck by the Izmit earthquake. Not surprisingly, many of these buildings collapsed (Figure 1).

Figure 1 (left) Sea shells in "concrete"

Figure 2 (right) Inadequate reinforcement in "RC" structural members
Both found in collapsed buildings after the Izmit earthquake

Missing bars or even too many bars (such that there is very little or no concrete to provide the bond between them) are just as bad. The bars also have to be of the correct length inside the concrete: splicing separate bars by using short overlaps or abutting the ends of bars together is structurally useless. Indeed, hooking the ends of reinforcing bars at column-beam joints (thereby creating hinges rather than moment resisting joints) in buildings devoid of any shear walls (meaning the joints are supposed to carry all the lateral loads from an earthquake), is tantamount to a death wish. Yet these defects in steel reinforcements were observed in many of the damaged and collapsed “RC” buildings after the Izmit earthquake (Figure 2).

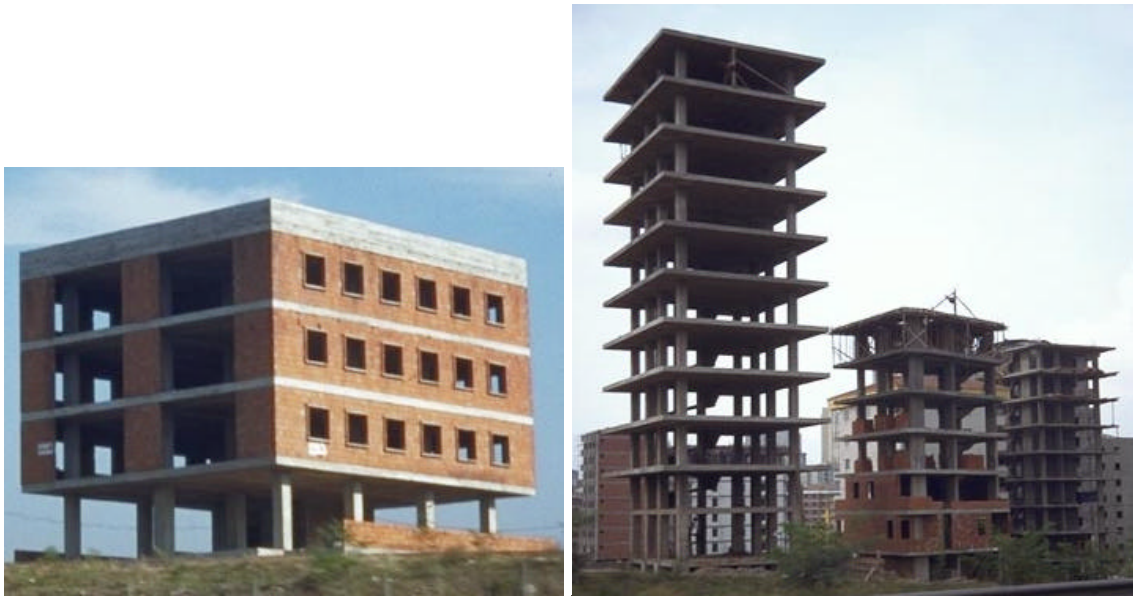
Another crucial aspect in the performance of RC buildings is the structural design that is chosen to resist vertical and horizontal loads. Previous earthquakes have shown that the inclusion of shear walls reduces the severity of damage and the incidents of collapse. Shear walls increase the structural redundancy of a building and absorb energy effectively, allowing some structural members to be distressed considerably, or even fail, without causing the complete collapse of the structure. This kind of fail-safe feature would be essential in the bad “RC” buildings described above, in which defects exist in the structural members themselves. But, incredibly, not a single shear wall was observed in AIR’s survey of the whole of the area around the Sea of Marmara affected severely by the Izmit earthquake, which included many thousands of buildings in an area from Istanbul and Yalova to Adapazari (Figures 3 and 4).

Without continuous structural shear walls, any discontinuities in the lateral stiffness of a building (such as the ground storey with the open columns in Figure 3, on which the upper three storeys sit as a stiff block) are likely to result in failure of the storey and collapse of the building. This type of collapse, termed “soft storey” collapse, is very common in major earthquakes (Figure 5). It should be noted that the external expanse of walls seen commonly on buildings (Figures 3 and 5, for example) are not structural shear walls, since they consist only of in-fill masonry (mostly hollow brick or hollow concrete blocks) and they are not tied to the “RC” frame (see Figures 4 and 6).

Figures 3 and 4 Buildings under construction alongside the Trans European Motorway between Istanbul and Izmit: cantilevered floor slabs and no shear walls

Another common feature in the “design” of these buildings in this region is to have floor slabs which cantilever off the perimeter structural columns, in order to augment the floor area above the ground floor (Figures 3 and 4). In many cases, for example, these cantilevers overhang pavements. The external walls of the buildings are built up from the edge of the cantilever at each floor, using brick masonry or, sometimes, concrete parapet or balcony features. These cantilevers therefore have to carry heavy loads. In many cases, the ratio (r) of the length of cantilever (c) to half the distance between the outer columns (b) is large. This geometry for the structural loads tends to reduce stability and the stability decreases as the ratio r increases (think of an inverted pendulum).

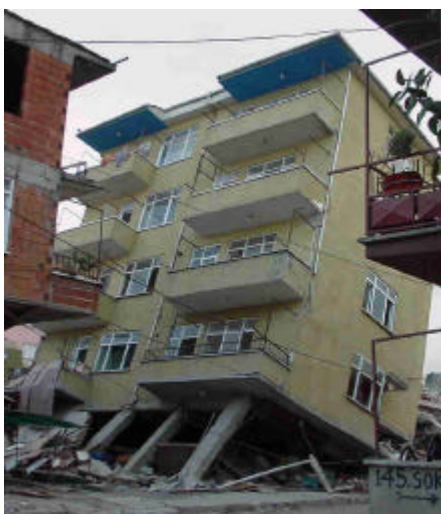
Figure 5 (left) Typical soft storey collapse

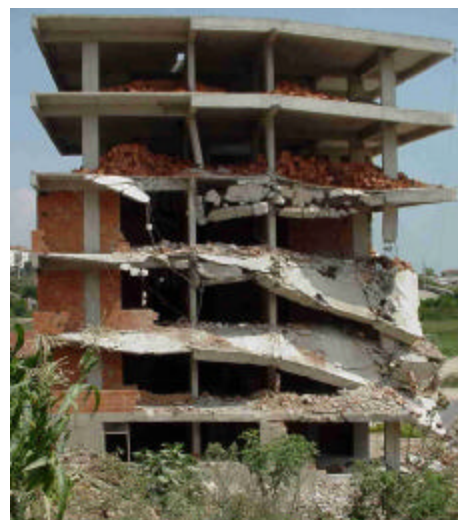
Figure 6 (right) Partial collapse of building due to failure of cantilevered floor slabs

In the case of narrow buildings the ratio r may be as high as 30% and the loads on the outer ground floor columns may be increased by as much as 50% compared to the loads for the case without cantilevers. This level of additional load, brought about solely by the configuration of a building, can make the difference between no collapse and collapse (Figure 6): between few or no casualties and many casualties.

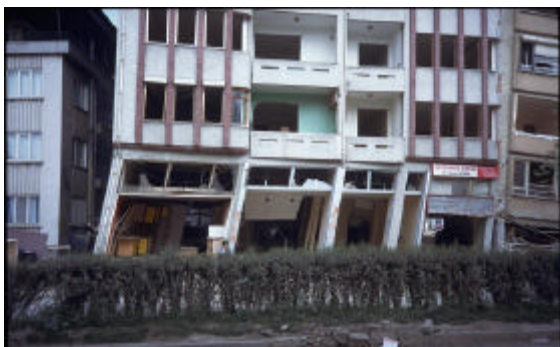
The label "reinforced concrete" has been misused and has been applied to very large numbers of buildings that are nothing of the sort in engineering terms. In these circumstances of pandemic bad vulnerability, the risk of suffering large numbers of casualties and huge economic losses from a major earthquake is very high indeed, as demonstrated by the Izmit earthquake. *Whole* groups of buildings with these pandemic bad characteristics will be damaged severely or will collapse: if one building goes, all are likely to go in a similar manner (Figures 7 and 8).

Figure 7 (left) Structural failure (soft storey) of a group of similar buildings

Figure 8 (right) A whole street suffers "RC" failure and soft storey collapse

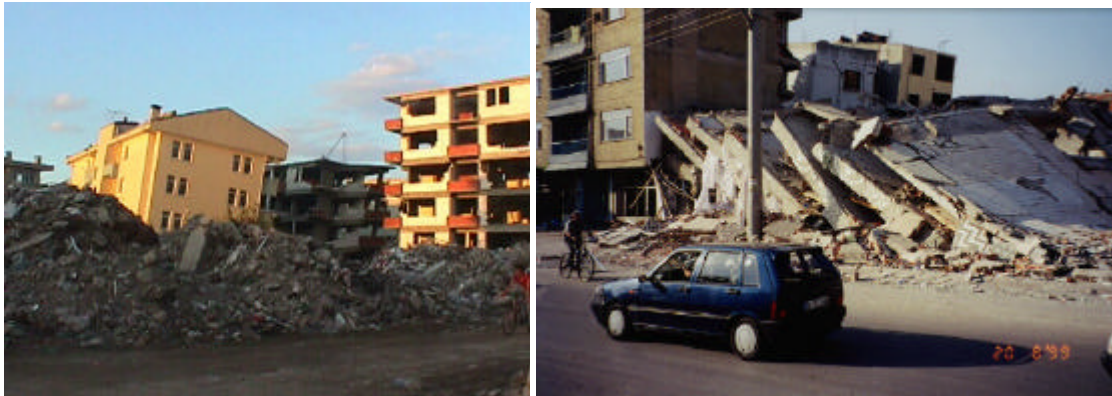
death trap without quite knowing which will or will not collapse and this comes close to the situation surrounding the Izmit event (Figures 9 and 10). This earthquake did a thorough job of picking out bad buildings: it destroyed around 66,000 housing units and damaged "moderately" another 66,000 (which are deemed to be dangerous to live in without repair and *strengthening* measures) and damaged "slightly" another 80,000 (which still require immediate repair). At least 17,000 people were killed and 44,000 were injured. At least 250,000 people were made homeless. The need for better buildings is clear.

Figure 9 (left) Various levels of damage: from complete disintegration (rubble in foreground) to soft storey failures to collapse of external masonry walls

Figure 10 (right) Typical death trap caused by complete disintegration of vertical supports and collapse of all floors. Notice that an adjacent building remained standing and was therefore not a death trap, even though it may have suffered damage in the RC structural members

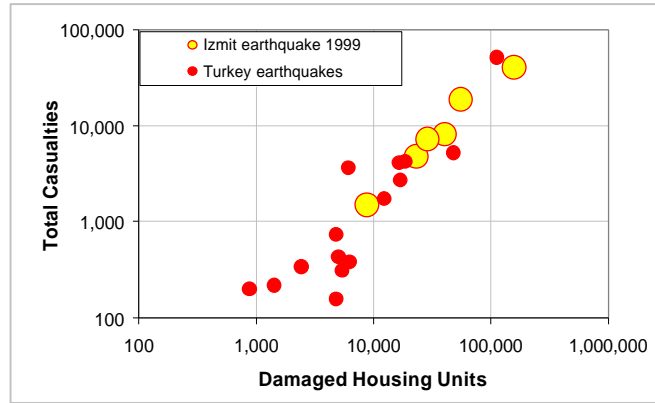
The potential benefits of improving the vulnerability of a building stock may be quantified, using historical data of damage and casualties and the levels of improvement that are possible. The data from the Izmit event show that there is a strong correlation of increasing casualties (killed and injured) with increasing number of buildings damaged (Figure 11). As shown, this correlation is consistent with that

from thirteen other major earthquakes in Turkey, which occurred from 1914 to 1998. This indicates clearly that the safety of buildings had not changed materially in a whole century, even though the methods of construction had shifted from vernacular adobe to “reinforced concrete”. The data on deaths and collapsed buildings are likely to be more objective than those on injured people and damaged buildings and they have been given greater weight in comparisons with data from different events.

Figure 11 Increase in total casualties with total damaged housing units, from the Izmit event (aggregated by province and total) and from 13 other earthquakes in Turkey from 1914 to 1998

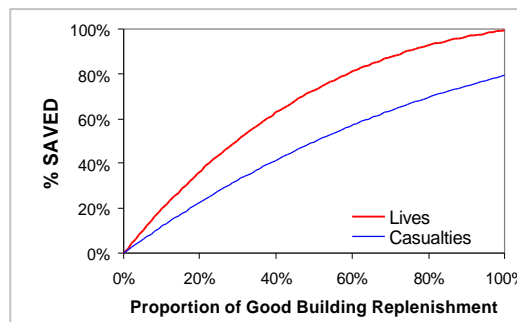
The vulnerability of RC buildings in California or Japan may be viewed as benchmarks, to which it would be possible to reduce the vulnerability of *new* RC buildings in Turkey. The data suggest that the number of deaths and of total casualties in Turkey would be reduced by around 35% to 75% and by 20% to 50% respectively by increasing the proportion of good buildings to around 20% to 50%, through a process of good building replenishment (Figure 12). Had this good building replenishment process taken place in the last 25 years in the areas affected by the Izmit event (during which period the proportion of new buildings in the province of Izmit was 67%), up to around 14,000 lives would have been saved. Achieving in Turkey the standards of RC buildings in California or Japan would save over 95% of potential deaths.

Figure 12 Potential increase in lives and casualties that would be saved as the proportion of good buildings in the building stock increases
