THE ATHENS (GREECE) EARTHQUAKE OF 7 SEPTEMBER 1999: THE EVENT, ITS EFFECTS AND THE RESPONSE

P. DIMITRIU, C. KARAKOSTAS AND V. LEKIDIS

Institute of Engineering Seismology and Earthquake Engineering (ITSAK)

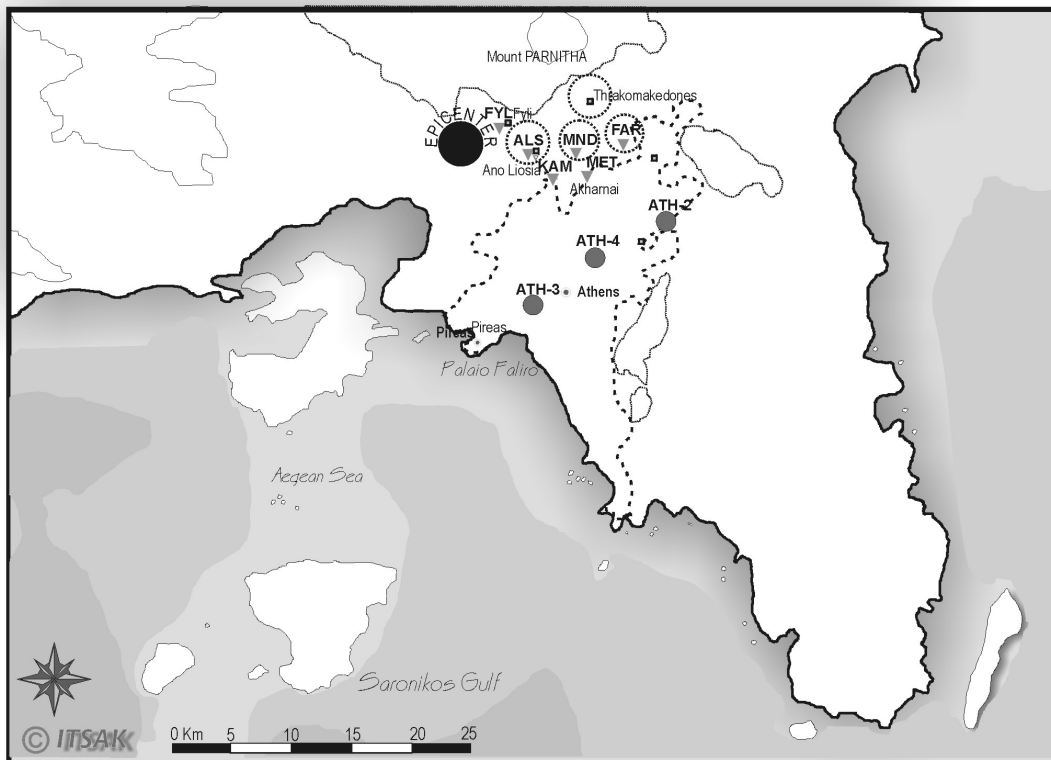
Figure 1. Map of the broader area affected by the 7 September 1999 (Mw 5.9) earthquake. Solid circles and triangles: permanent and temporary strong-motion stations operated by ITSAK. Dashed circles denote regions where Modified Mercalli (MM) intensity was from VIII to IX degrees.
